The Birks of Aberfeldy Management Plan 2022 – 2027

(October 2022)

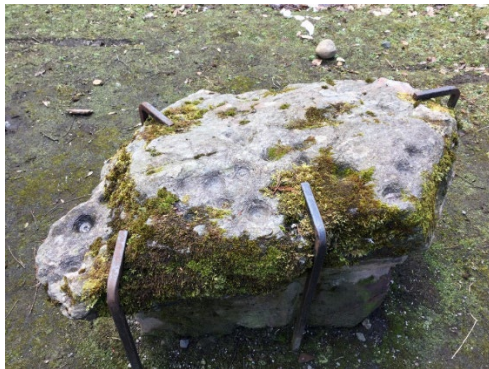
Cup-marked rock

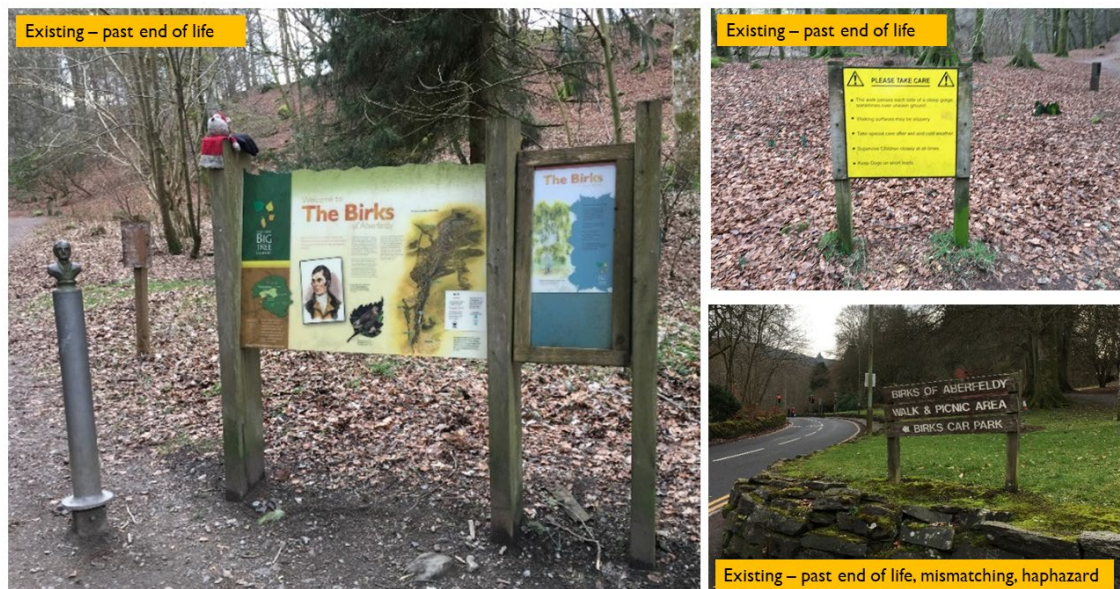
- Signage – Orientation and Interpretation:
 - Welcome outdated and low quality at all access points
 - Site orientation confusing and out of date with how the site is used and accessed
 - Signage:
 - haphazard,
 - mismatching,
 - past its end of life,
 - excessive and repetitive
 - lacking up-to-date information

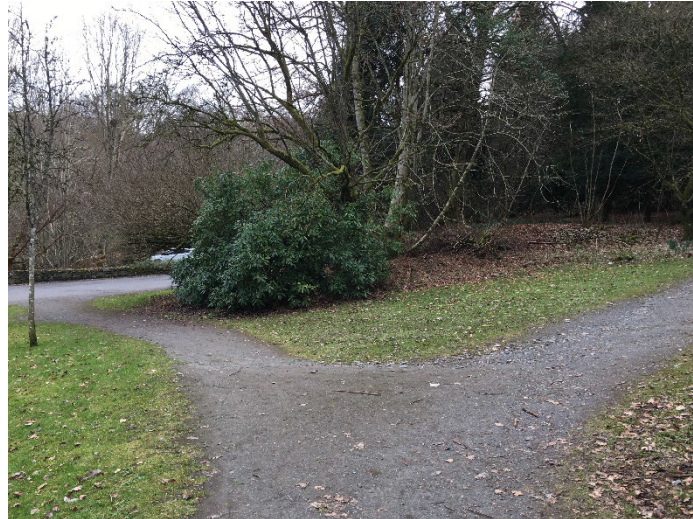
Important junction arriving at Upper Birks or transitioning between Lower and Upper. Key location for signage and waymarking

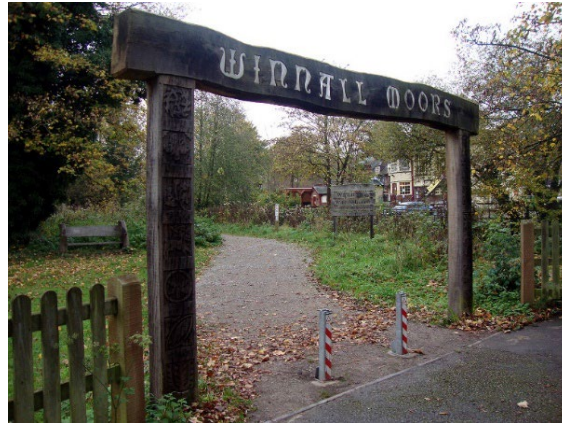
Example of aesthetically designed height restriction barrier: Winnall Moor, Winchester, Hampshire
