Den o' Alyth Management Plan 2023 – 2028

(DRAFT May 2023)

1.0 Introduction – the Plan and Partnership

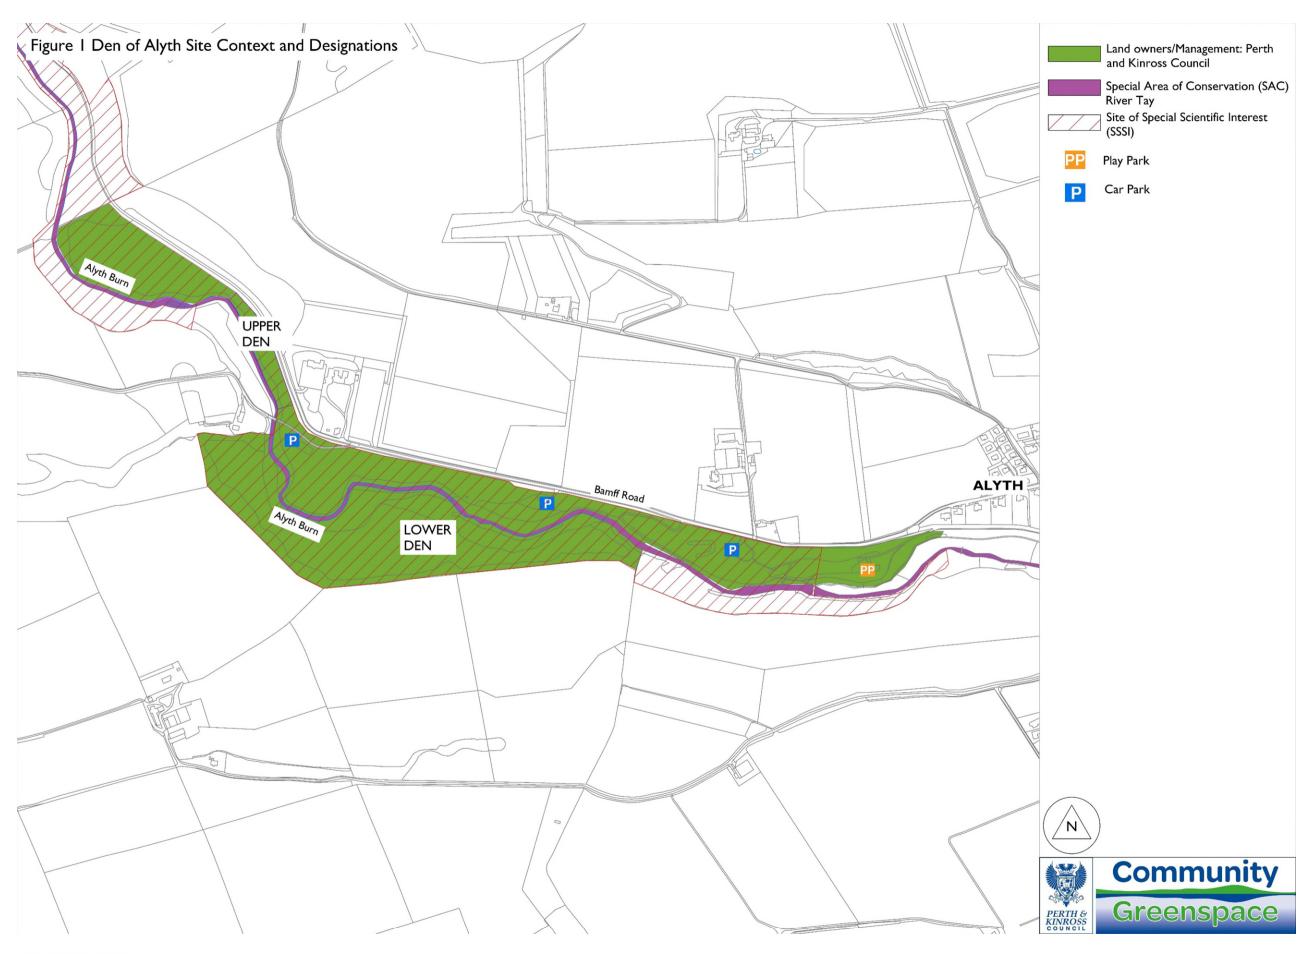
The Den o' Alyth is a highly valued landscape as demonstrated by its designations (Figure 1) and listed below:

- The vast majority of the site is a Site of Special Scientific Interest (SSSI).
 See Ecology section.
- The entirety of the Alyth Burn within the whole of the site is a Special Area of Conservation (SAC). See Ecology section.
- The Den of Alyth forms a part of the Broad Valley Lowlands Tayside Landscape Area (SLA)

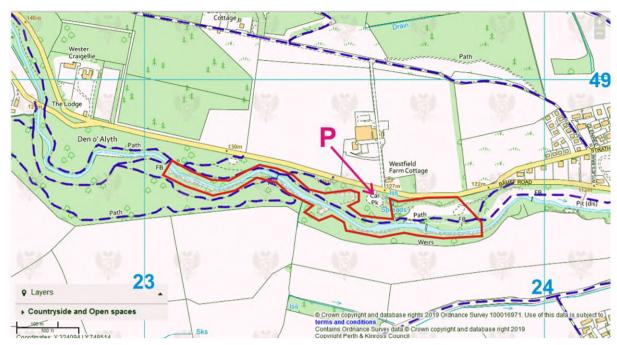
Image: Extract from PKC Local Geodiversity Site citation. Red line indicates area of interest; 'P' indicates car park.

The primary interests of geoscientific value are the Old Red Sandstone rock types, the river processes, and Basalt dyke; all to be found of 'good' to 'very good' quality.

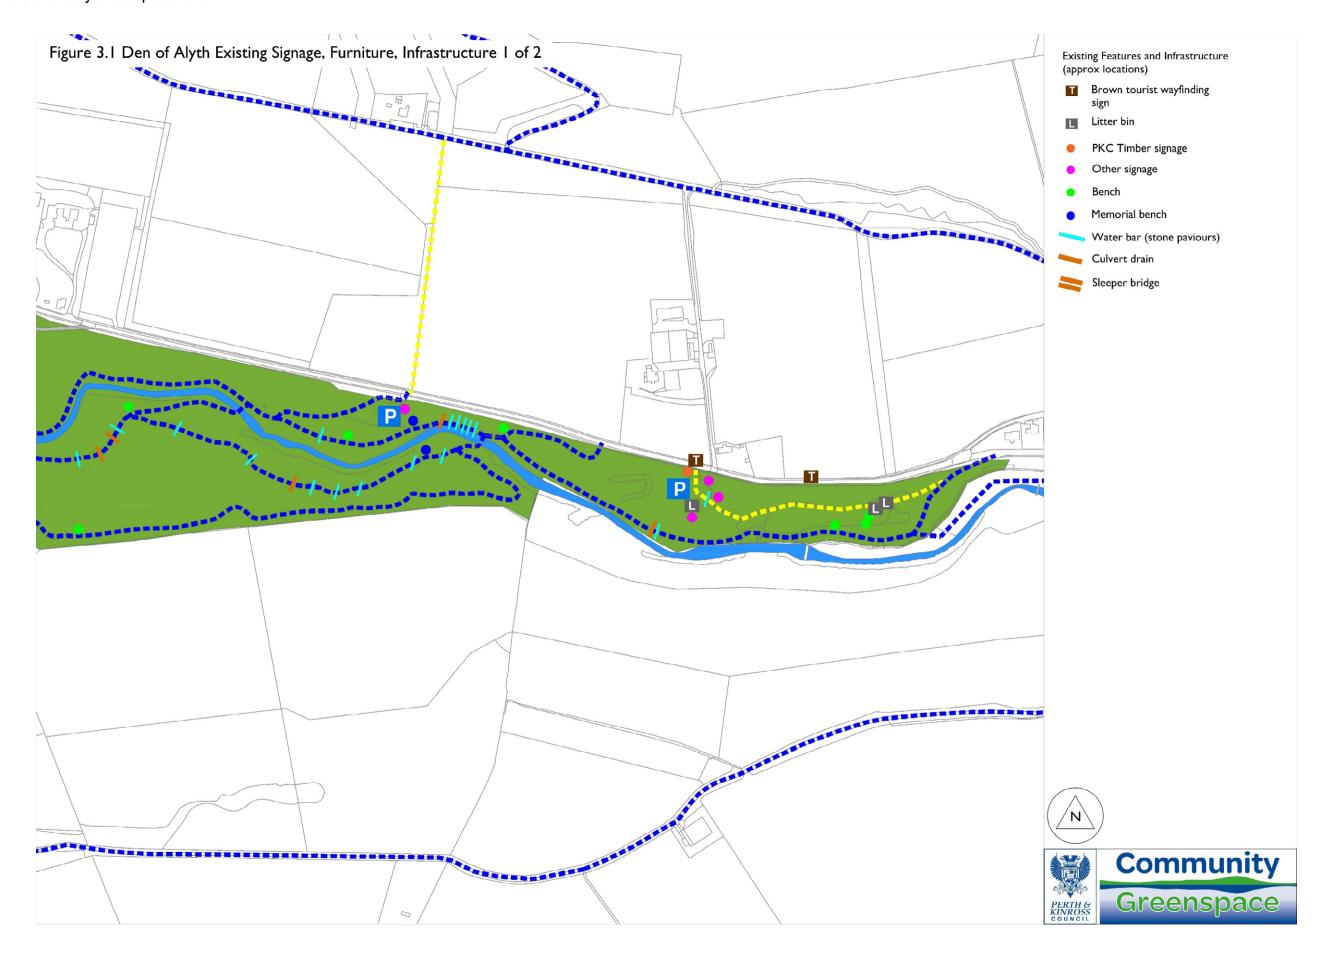
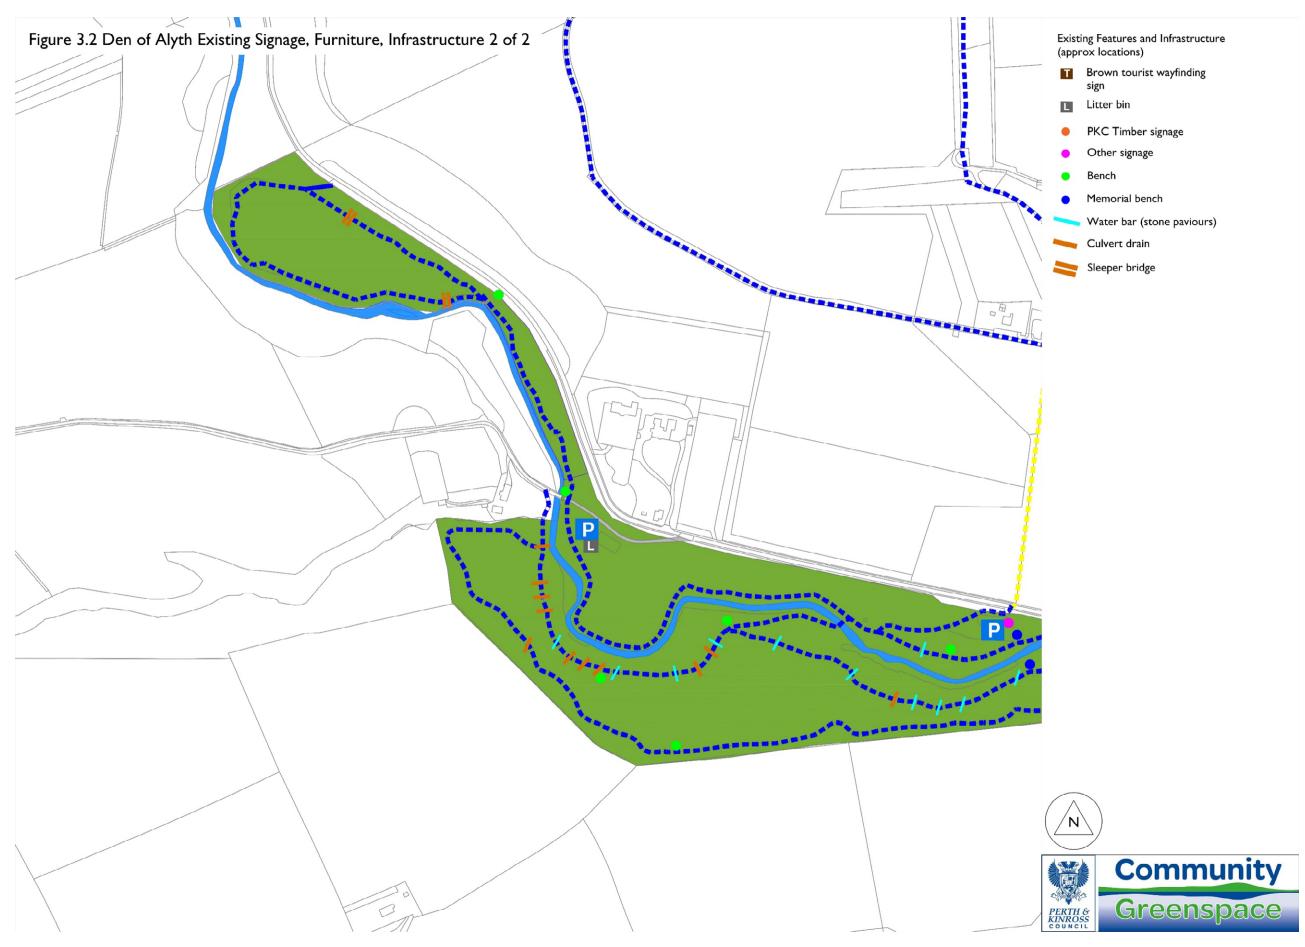
The current infrastructure on site is shown on Figs 3.1 and 3.2.

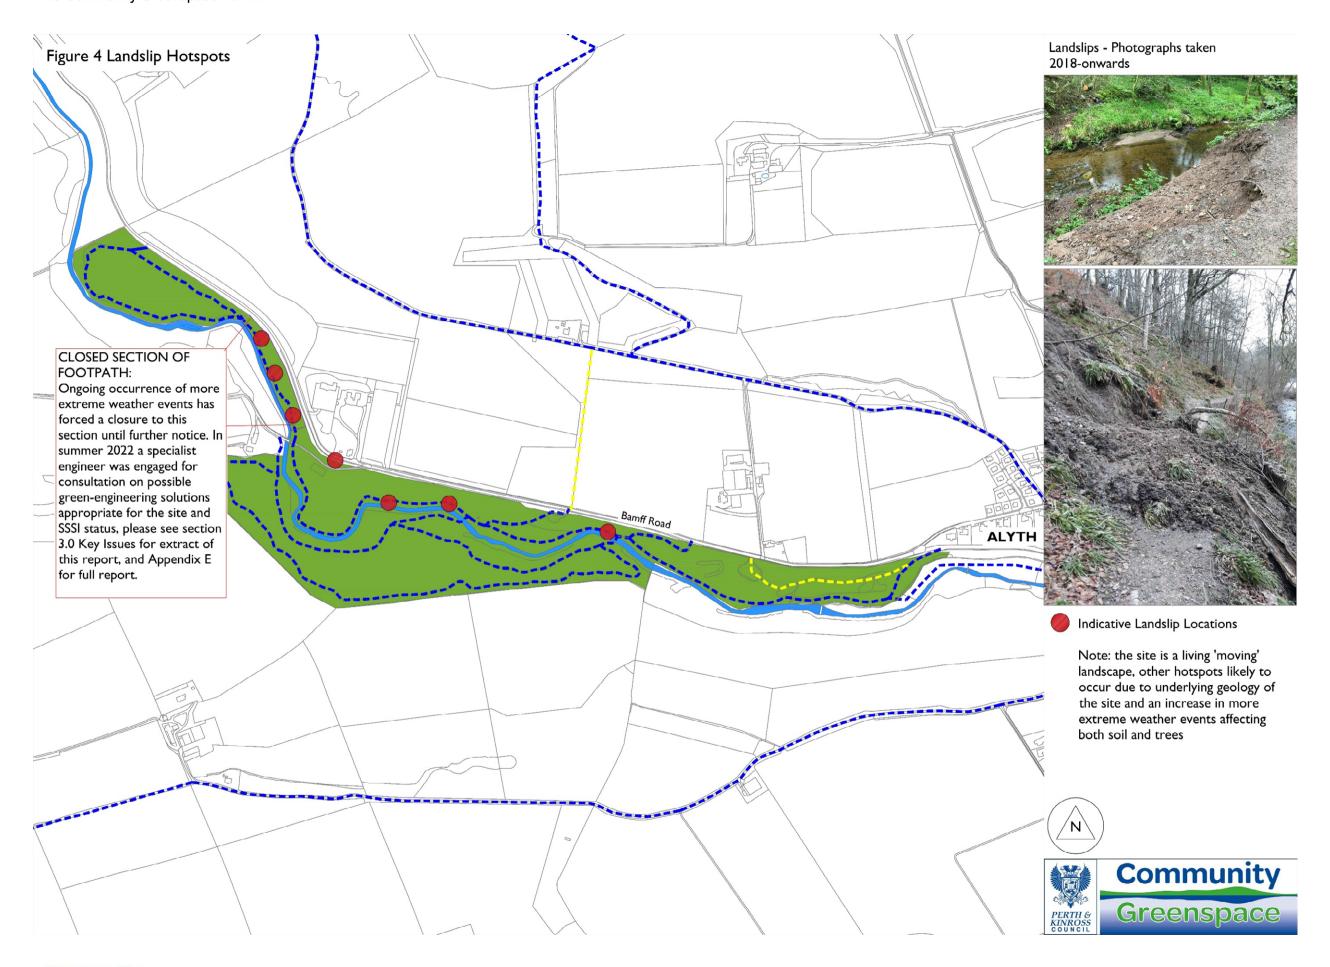
There are several hotspots for landslips (see Figure 4) where sections of path, including the Core Path, have fallen away or are in the ongoing process of erosion. While some sections in the Den may be considered for repair with NatureScot consultation and approval; the Upper Den is more severe. Larger sections of path are starting to fall away as part of erosion processes, accelerated by higher frequency of more extreme meteorological events.

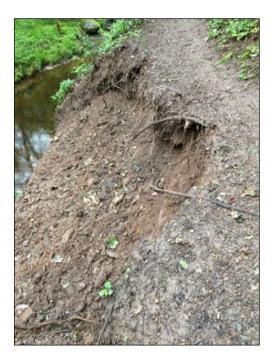
"The existing path is unmade and is generally narrow and uneven, extremely so in places. There is also evidence of significant erosion (water damage) along the length of the path, with some sections washed away, loose or undermined. The evidence suggests that the erosion has principally been caused by water running off the upper slope and across the path to the burn, rather than by high water levels in the burn (although this may have been a contributory factor). (...) There is extensive evidence of slope instability uphill of the path, characterised by shallow rotational or translational slip failures, many if not all of which are still potentially active (...). The same applies downhill of the path."

Photo: Landslip in Upper Den

The report concludes that due to the nature of the site, and furthermore due to limitations on engineering options within a SSI designation, it is not deemed efficient nor a guaranteed solution to the problem to try to 'repair' and stabilise the existing path where it is most severe and therefore closed to the public for safety reasons. Figure 6 outlines options for management of landslides and other less severe erosion spots.

Figure 6 outlines the proposals on how to approach landslides and erosion at the Den. Option 1 is a combination of approaches in 3 parts, where all or only some may be agreed as the way forward. Option 2 is an additional possibility that would take us beyond the 5 year plan but could be commenced during that time to take forward with a pathway of funding, land permissions and re-routing of core path. In both cases, it is not feasible nor economically feasible to repair the closed section however temporarily, due to the low chances of success, accessibility, and cost.

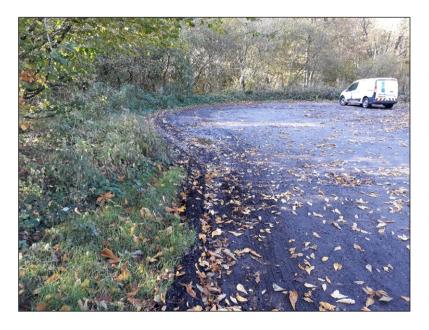
- Parking areas worn and unwelcoming (signage improvements will assist with this)
- Overnight camping with issues of waste and littering
- Fly-tipping in 'middle' car park; intermittent low usage of car park resulting in antisocial behaviour
- No accessibility information

Photo: 'Middle' Car Park

Car Parks						
8	All Car Parks	Surfacing in poor condition	High	Resurface all car parks	Rationalise car park edging to re-design for resurfacing	PKC Community Greenspace /Contractor	Approx Costs: £50k Eligible UKSPF/PKC/WIAT

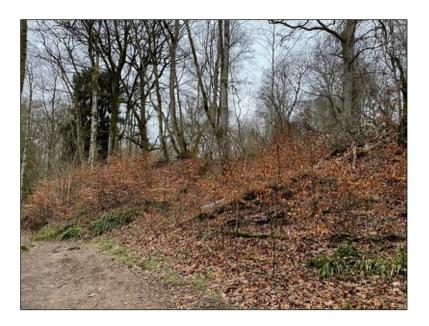
- SSSI in 'Unfavourable No Change' condition mostly due to widespread presence of beech (especially high presence in Upper Den and in adjacent woodland) and sycamore that prevent natural regeneration of native species
- Increasing instances of Ash Dieback
- Falling trees with landslips

Photo: Dominant beech

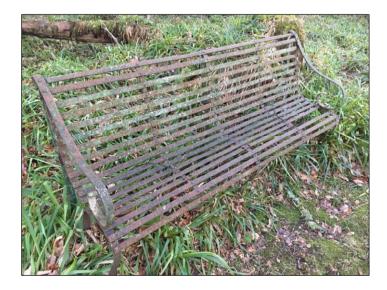
- Sections of path network eroded (landslip-specific damage treated separately in above section) and in need of improvement
- Drainage issues contributing to erosion of paths
- Minor bench works
- Dog waste and litter

Photo: Bench for repair or removal/replacement

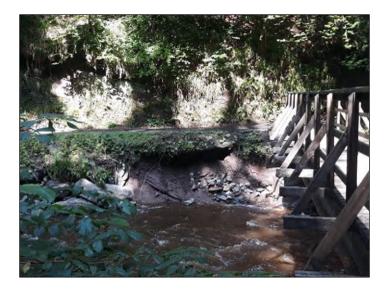
Photo: Path erosion

ommunity Greenspa Location	Existing condition	Priority	Outline Proposal	Key Actions/ Next steps	Who could do the work	Approximate cost
				sloped areas (ref PKC Forest Plan)			
	Infrastructure						
7	Paths	Sections of paths in poor condition due to run-off/surface water erosion and general wear and tear	High	Approx 40% of total surface area to be resurfaced and re-graded where necessary Including installation of cross falls and drainage features where necessary	Funding and tender package/specification as per SSSI requirements	Use of contractor	Approx Costs: £50k Eligible UKSPF/PKC/WIAT funding: £TBC approx
	Timber retaining walls	Sections of walls old and deteriorating	Med	Replace retaining timber walls with upgrade retaining structure	Employ engineer services for spec and tender for implementation where necessary	PKC Community Greenspace, Contractor Engineer	Approx Costs: £7k PKC/WIAT funding: £TBC approx
